Destructive Single-Event Effects in Diodes

Megan C. Casey¹, Jean-Marie Lauenstein¹,
Michael J. Campola¹, Edward P. Wilcox², Anthony M. Phan²,
and Kenneth A. LaBel¹

¹NASA Goddard Space Flight Center

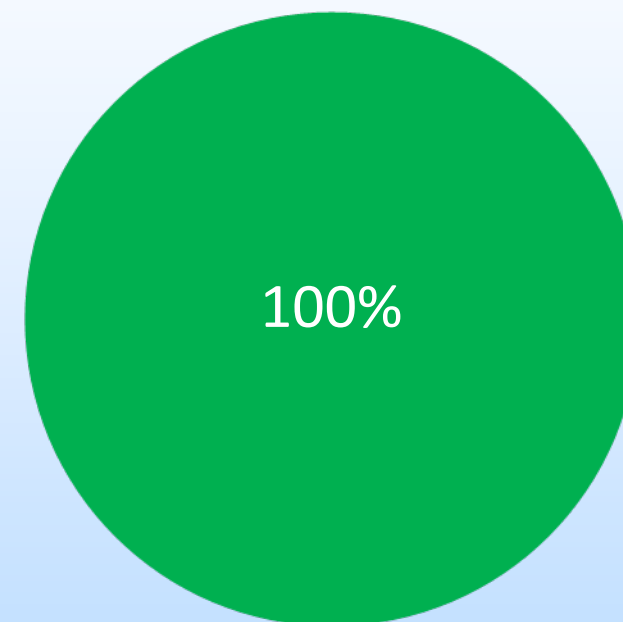
50% of Reverse Voltage

By derating to 50% of the reverse voltage, all failures are eliminated for the parts tested

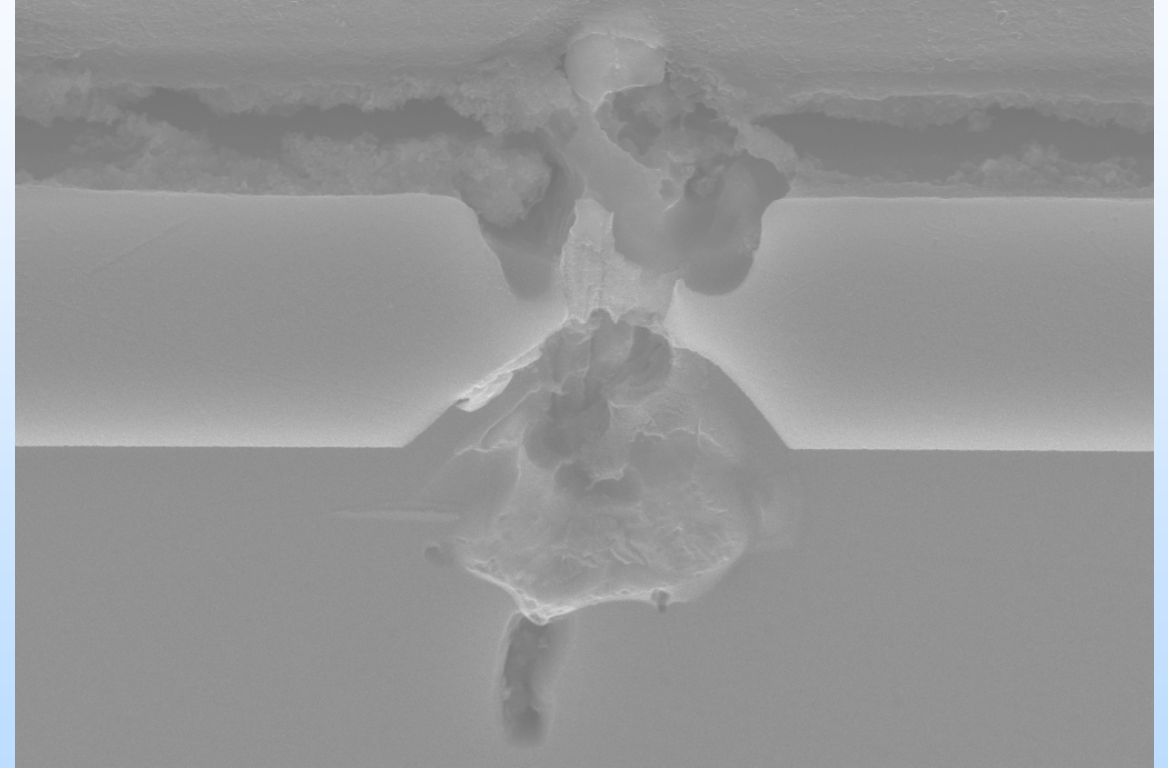
Scanning Electron Microscope Image

Metal has clearly displaced from Schottky junction into void
formed from high current
